TA-8910 NEP: EARTHQUAKE EMERGENCY ASSISTANCE PROJECT

FINAL REPORT ON SHAKING TABLE TESTING

TA-8910 NEP: Earthquake Emergency Assistance Project Experimental Verification of Remote School Type Designs

May 2019

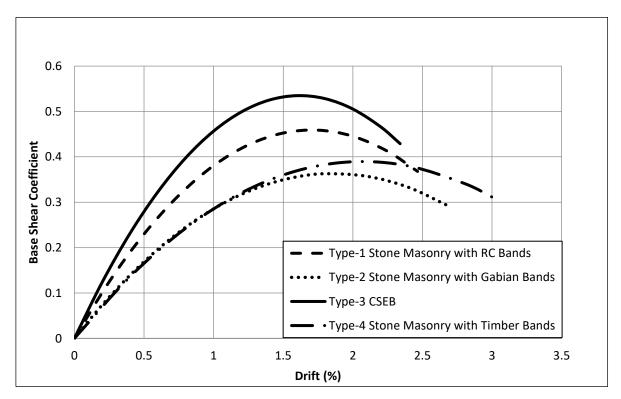
Figure ES 1: Combined Capacity Curves of all four Type Designs

base excitations up to 1.0g. Moreover, the 1/3rd reduced scale models were subjected to acceleration time history of the Northridge 1994 earthquake record, compatible with 5% damped elastic acceleration spectrum (India Standard IS: 1893), linearly scaled from 5% to 240% (that is equivalent to 1.0 g). The 1/3rd scale models of Type Design 2, 3 and 4 were also subjected to KIRT_EW. The KIRT_EW time history was recorded at Kirtipur, Kathmandu on a rock site from the 25 April 2015 Gorkha earthquake and was used as supplementary test. Consequently, the shake table tests were conducted according to the aforementioned methodology. The experimental data obtained from both the tests was used for plotting the force-deformation capacity curves, as shown in Figure ES 1.

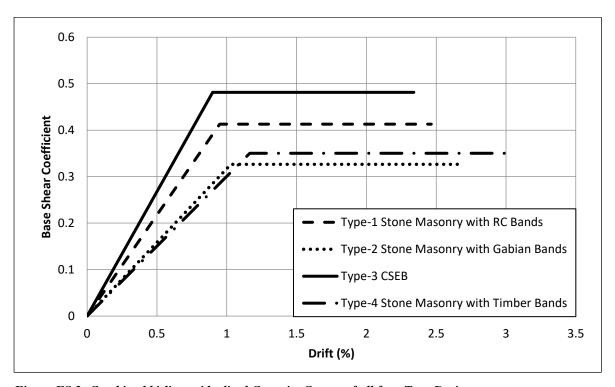
Figure ES 2: Combined bi-linear idealized Capacity Curves of all four Type Designs

tested in the transverse direction. Following, testing of the repaired 1/3rd scale Type Design 3 model, it was also tested in the longitudinal direction without any further repair. The 1/3rd scale Type Design 1, 2 and 4 were also re-tested after removal of 50% and 100% containment wires from the wall surfaces. The force-deformation capacity curves were bi-linearized as elasto-plastic curves to obtain the response modification factor (R-Factor), reported in Table ES 4. The combined bi-linear idealized capacity curves are shown in Figure ES 2.

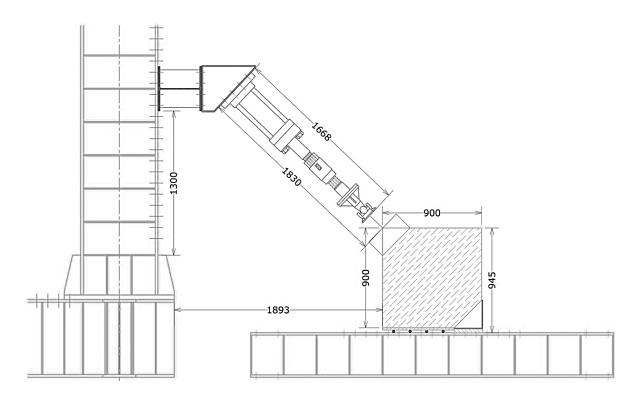
Figure 23: Diagonal Compression Test Setup

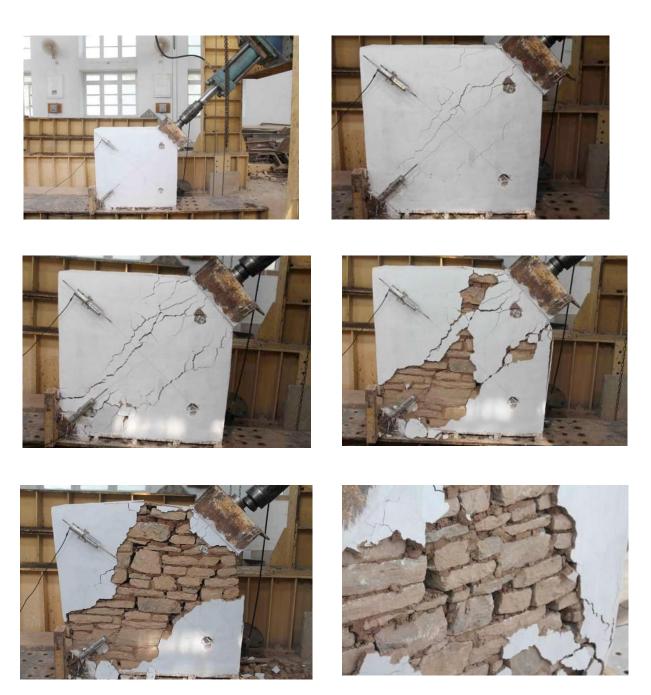
Figure 30: Damage evolution of the stone masonry wall in unstabilized mud mortar under diagonal tension $test-without\ containment$

Figure 24 shows the damage pattern of the wallette at the ultimate state. Figure 25 to 28 shows the shear stress versus shear strain behavior of tested wallettes, while Figure 29 shows combined plot of all specimens. Figure 30 to 32 shows the damage evolution of tests wallettes under diagonal compression loading.

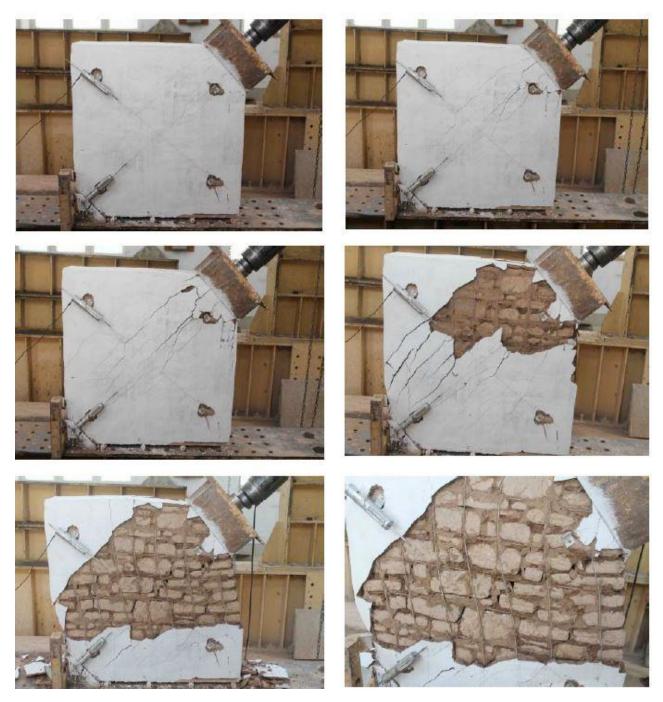
Figure 31: Damage evolution of the stone masonry wall in unstabilized mud mortar under diagonal tension test – with containment

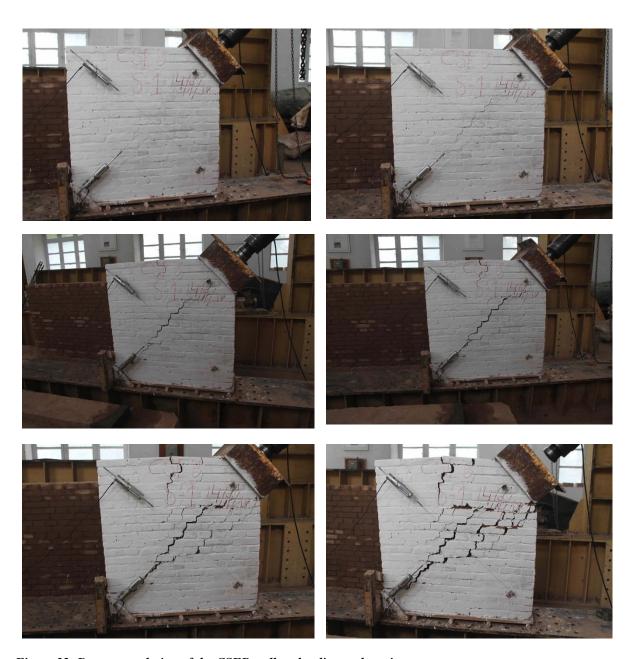
Figure 32: Damage evolution of the CSEB wall under diagonal tension test

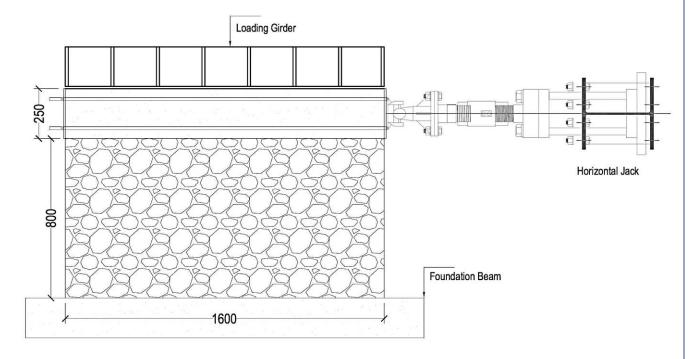
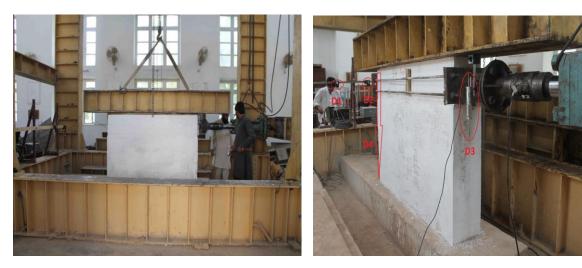
Figure 33: Test setup for in-plane quasi-static cyclic tests on masonry piers (pier thickness scaled to $2/3^{rd}$ of the prototype)

Four displacement transducers were used to measure displacement at four different locations as shown in Figure 33. String pots 1 and 2 were used to measure horizontal displacements at the horizontal load level on both faces of the specimen while gauge 3 and 4 were used to record vertical rocking displacements at both ends of the specimen. All these load and displacement gauges were connected to the data acquisition system, UCAM-70.

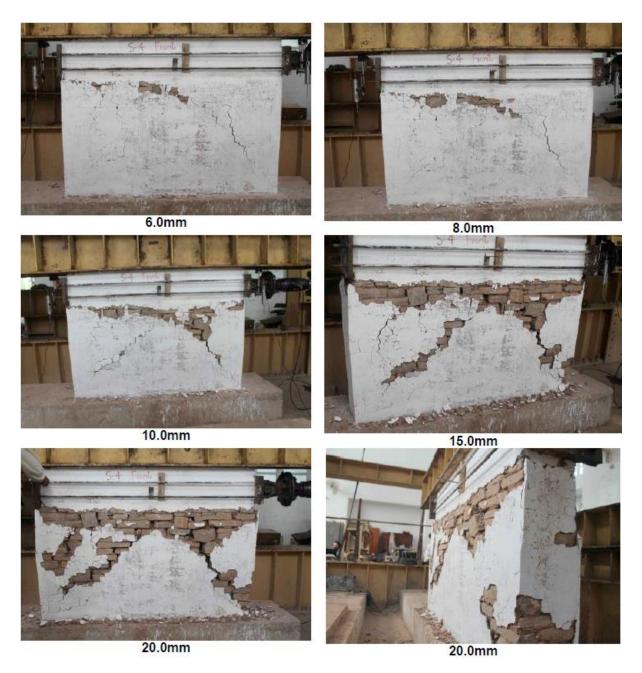
Figure 39: Damage evolution of the stone masonry wall under in-plane quasi-static cyclic load - No Containment

Figure 39 and Figure 40 shows the damage evolution of stone masonry walls; with and without containment, subjected to in-plane loading. Under smaller lateral displacement, only few slight cracks were observed in plaster, which increased spatially upon subjecting wall to large displacement resulting in the spalling of plaster. The wall compressed vertically, and the individual stone units experienced sliding under lateral load. For specimen with wire containment, the wall distortion stressed the containment wires in tension, providing capacity against lateral loading. The alternate tension-compression and vertical settlement of stones to get packed, resulted in to the buckling of wires. However, the containment kept the stones in cage and didn't allow the partial and total collapse of wall. Due to vertical settlement under large displacement, wall with containment was observed with little out-of-plane bulging, however, stone dislocation and stone sliding was observed in wall without containment.

Wall without containment was observed with horizontal crack at the top beam bottom level and roughly diagonal cracks. The diagonal cracks width increased with increasing lateral displacement demand that resulted into separation of wedge like portion from masonry walls on both left and right top ends. The wall was also observed with out-of-plane bulging and sliding of stones and the specimen was found in incipient collapse state. Table 19 reports the mechanical properties calculated for stone masonry walls.

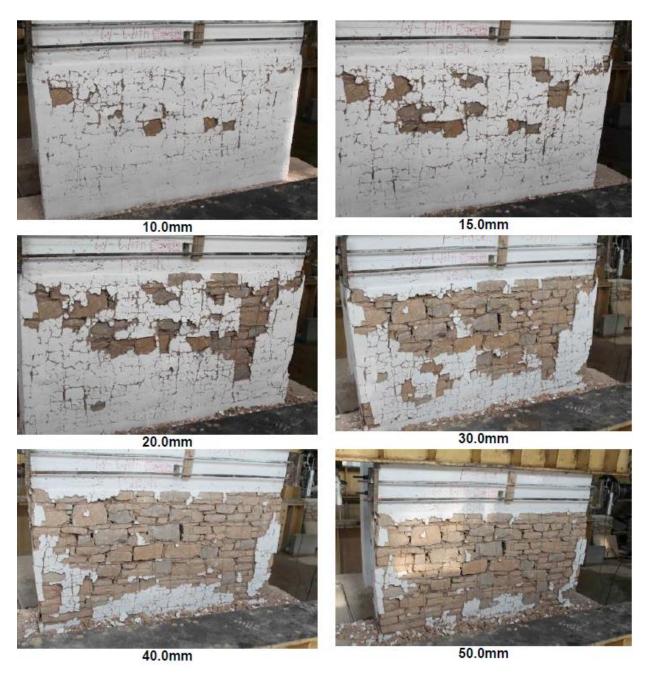
Figure 40: Damage evolution of the stone masonry wall under in-plane quasi-static cyclic load – Containment (Sample no. 2)

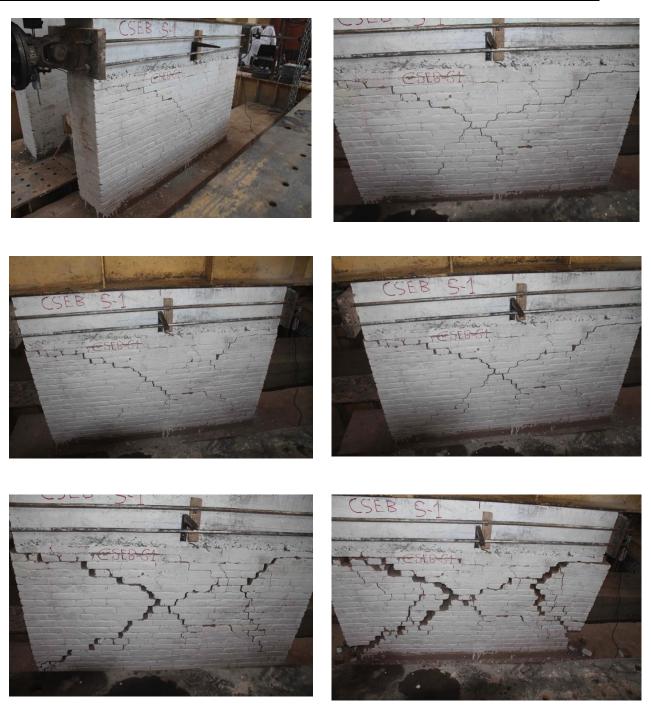
Figure 46: Damage evolution of the CSEB wall under in-plane quasi-static cyclic load-Wall S1

Figure 46 and 47 shows the damage evolution of the CSEB wall specimen, subjected to inplane loading. In case of wall S1, under smaller lateral displacement cycles, clear diagonal cracks were observed on both diagonals, which aggravated upon subjecting wall to large displacement resulting in severe diagonal shear cracking along the mortar joints. Table 19: Stone Masonry wall in-plane response parameters

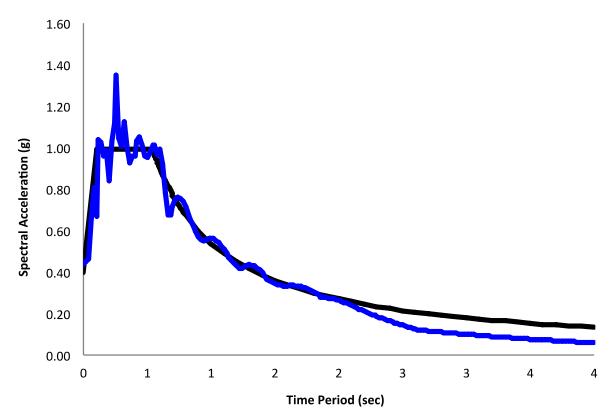
Figure 56: Compatibility of acceleration record spectrum and code specified elastic response spectrum

history of the Northridge (USA) earthquake of 17th January 1994 recorded at 090 CDMG STATION 24278. The acceleration time history was matched to the code specified design acceleration spectrum (IS 1893) (Refer Figure 56). The 1/3rd scale models (Type Design 2 and 3) were also tested on the shake table after cosmetic repair and were subjected to the same testing protocol to which the virgin model was subjected to. Additionally, the models were tested on KIRT_EW time history. The repaired model of Type Design 3 was also tested in the longitudinal direction after testing it in the transverse direction.

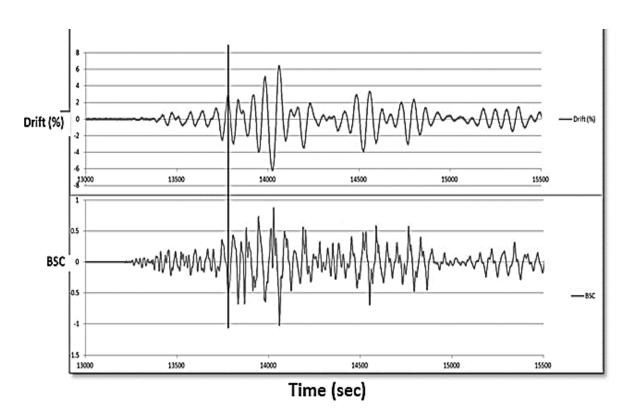
Figure 65: Drifts and corresponding base shear coefficient

The in-plane capacity of test model was presented in terms of base shear coefficient (BSC), which is calculated using the procedure described in Ali et al. (2013). This involved transforming model observed peak acceleration on in-plane walls (average of the two in-plane walls) at the eave level to prototype using the actual applicable scale factors for model to prototype conversion (Tomazevic, 2000). The in-plane walls' response acceleration was multiplied by the structural masses including self-weight of roof (timber trusses and purlins and GI Sheet) and loadbearing walls (considered as 50% of the total mass of walls).

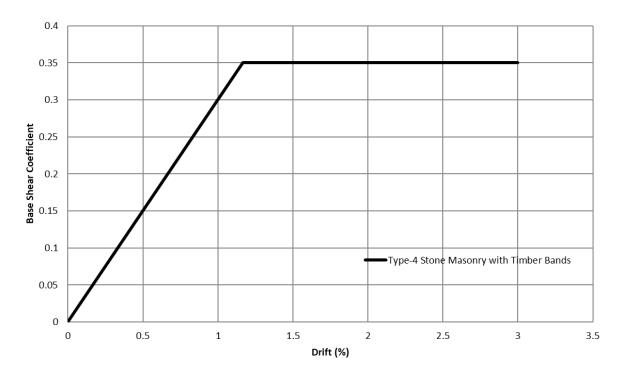
Figure 73: Bi-Linearized Lateral Force Deformation Capacity Curve- Type Design 4

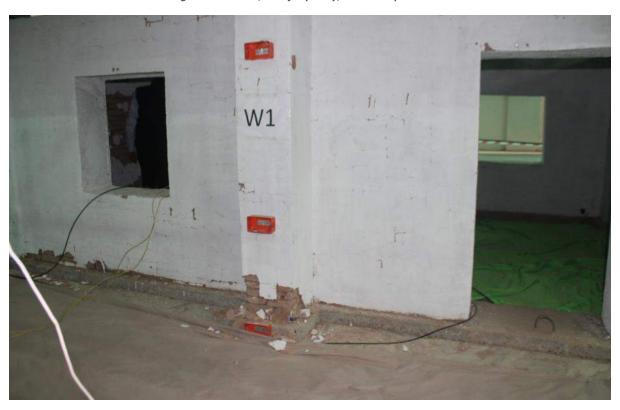
Figure 16: Run 20, 4 Hz frequency, 12 mm displacement

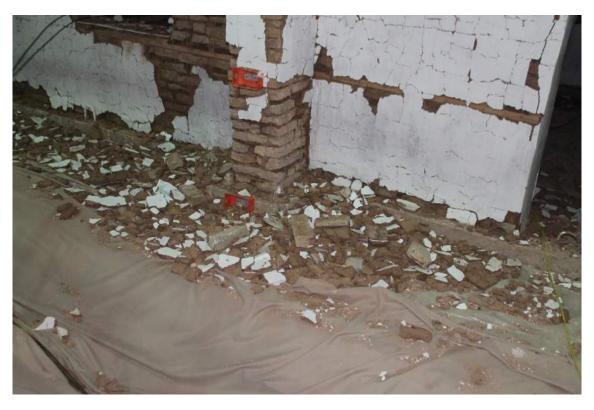
Figure 12: Run-17, 4 Hz frequency, 15 mm displacement

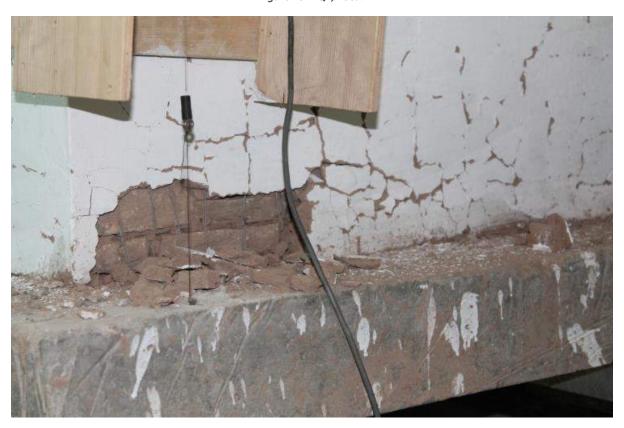
Figure 20: EQ2, 100%

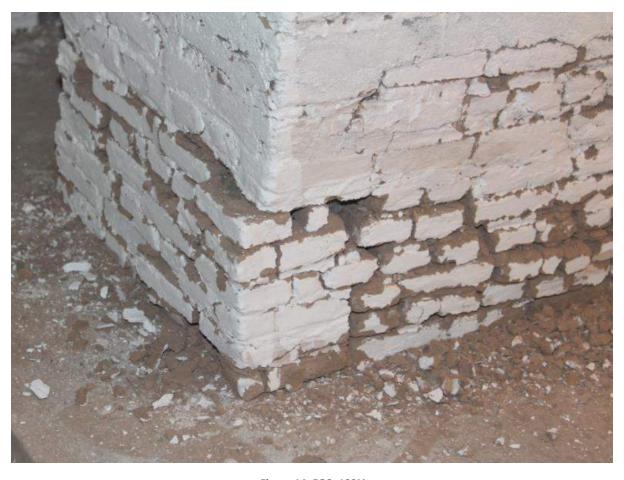
Figure 14: EQ2, 100%

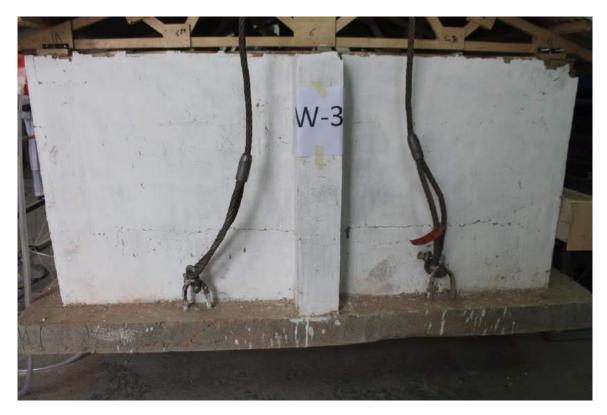
Figure 1: EQ1, 100%
